The Aussie Mossie

NUMBER 37

SEPTEMBER 2003

The New Navigator — Brett Clowes

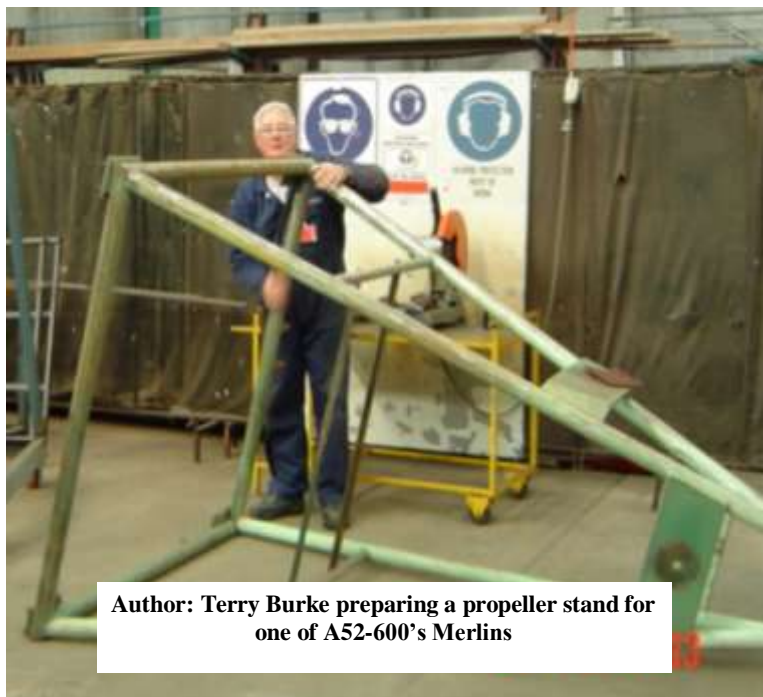
Author: Terry Burke preparing a propeller stand for one of A52-600's Merlins

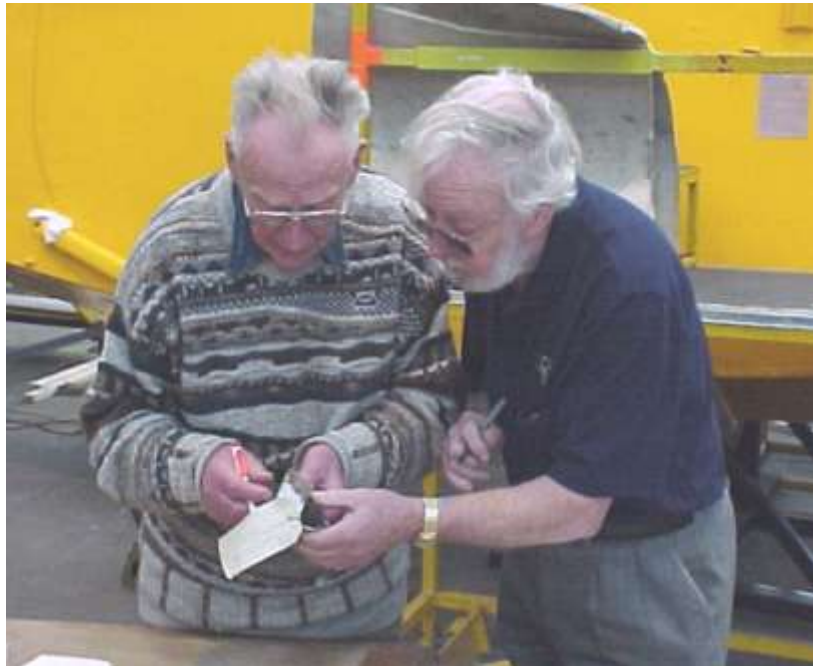
Lindsay and John going through the painstaking effort of identifying some of the small components from Mosquito A52-600.

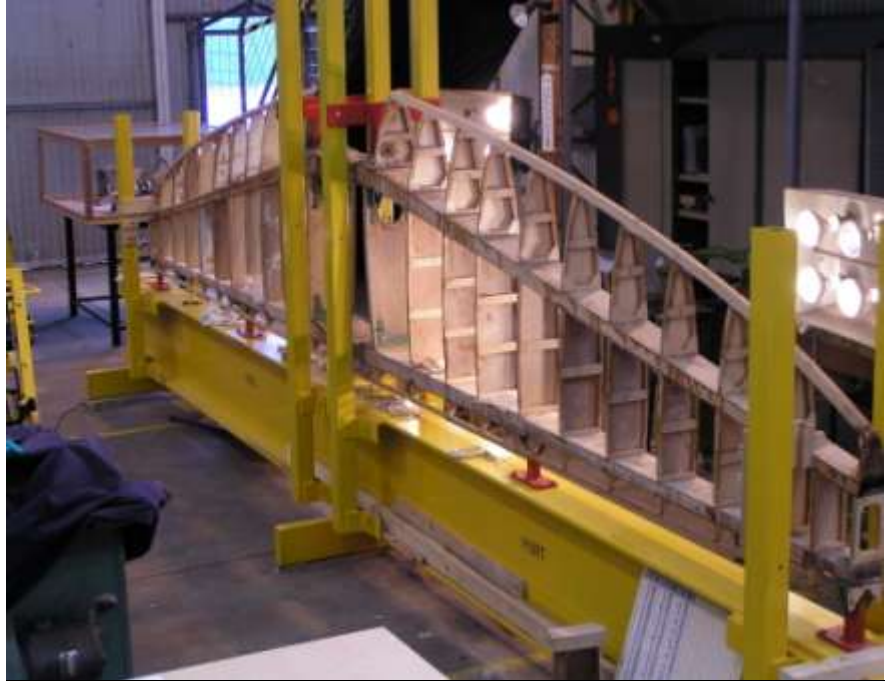
The tailplane would not dare move during restoration —
in this slightly over-engineered jig.

Right below the public-access catwalk in the Restoration Hangar, the tailplane's taking shape on a specially constructed jig, . . . , which allows us to rebuild it to its original specifications maintaining precise dimensions and the alignment of various attachment fittings. The aircraft's actual structure is the visible tip of an iceberg. That jig's part of the iceberg; over time, we've acquired sets of drawings not just of the aircraft itself but also for the jigs, fixtures and tooling aids on which the original aircraft were built. So the horizontal stabiliser jig is the first of many heavy fabrications we will need to construct during the restoration of the Mosquito. Additionally, adapting the workshop for aircraft woodworking is absorbing a lot of energy. We purchased dozens of different clamps to hold the glued joints together, then found we needed trolleys to keep them readily available as and when we need them. The list goes on and on; we'll need shadow boards for special woodworking tools we are acquiring, more racks for hundreds more clamps, and so on.

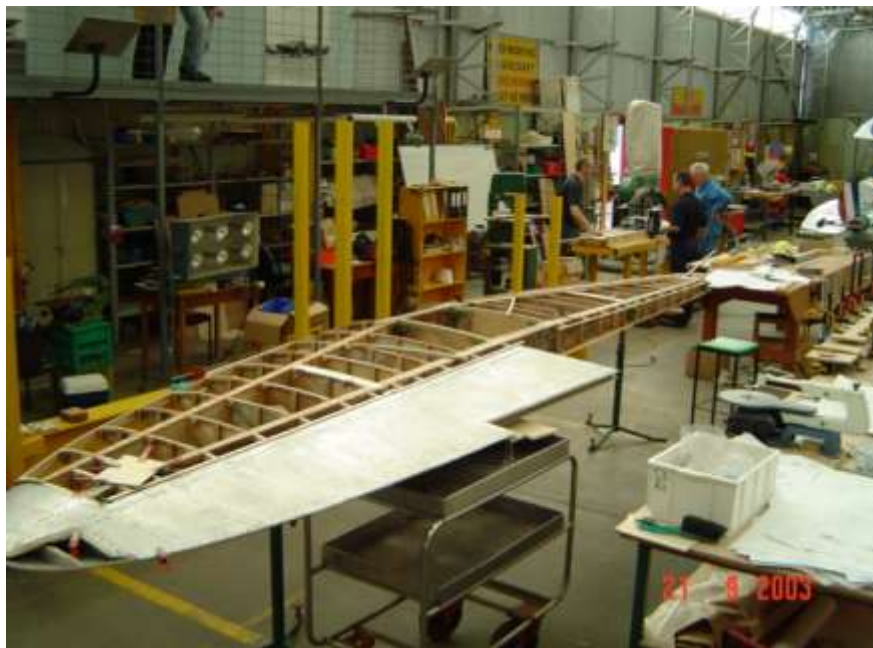
The tailplane is now ready to have its skin reattached.

Back to the tailplane. The original certainly looked fine, but knowing the glued joints were structurally unsound, we took it apart and removed the faces off the spars. The joints in the spar booms laminations were in fact OK (laminating used a different process), but there were small areas of localised rot around some of the boltholes. We also found that some of the plywood rib webs had become brittle and in some cases delaminated. An inspection of the fuselage showed that it is suffering from the same problems.
